APPENDIX F

SPRING GULCH DETAILED COMMUNITY ASSESSMENT RESULTS

CWPP Community: Spring Gulch

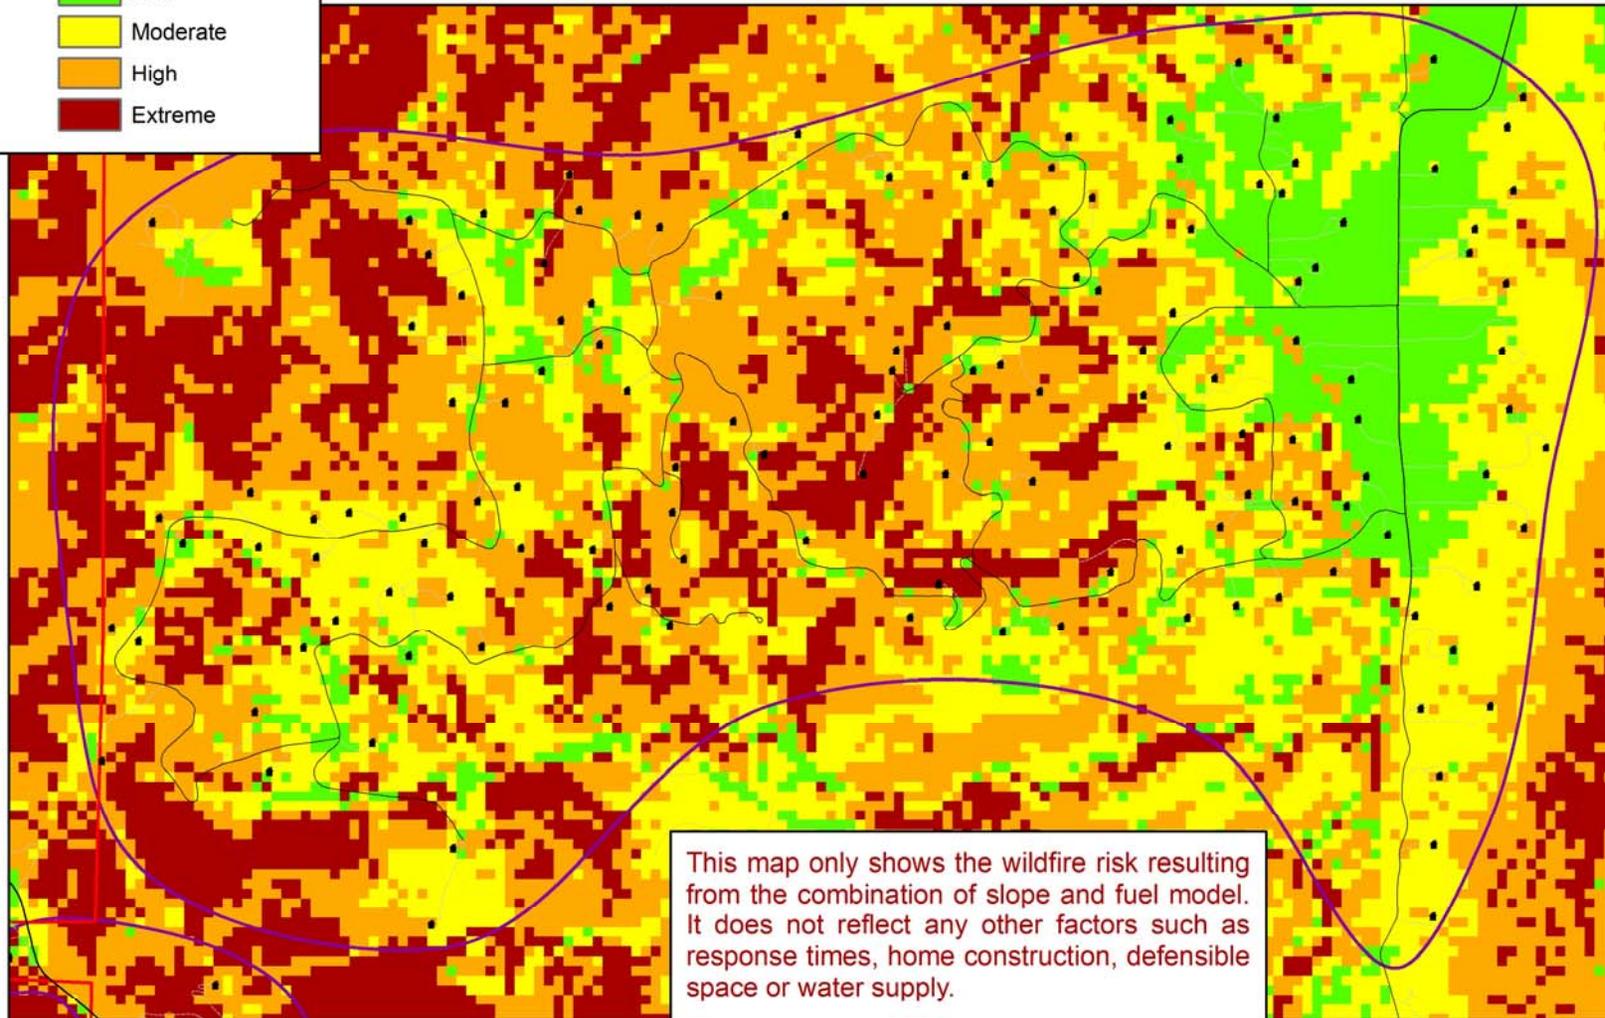
Combined Risk from
Slope and fuel Model
