APPENDIX N

APPLE VALLEY DETAILED COMMUNITY ASSESSMENT RESULTS

CWPP Community: Apple Valley

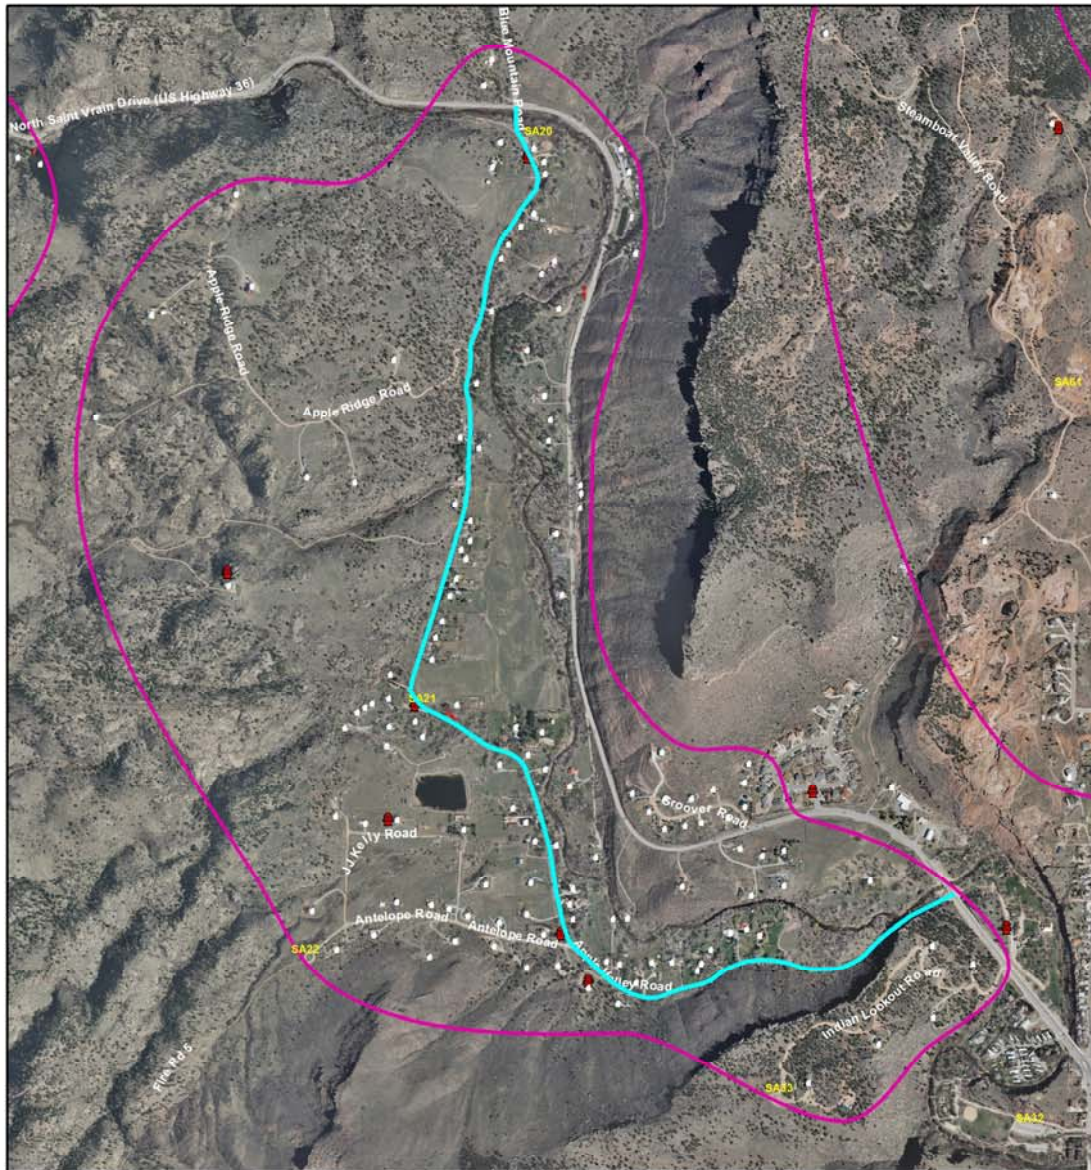
Wildfire Risk: Moderate

Apple Ridge &
Indian Lookout Road
Risk: High

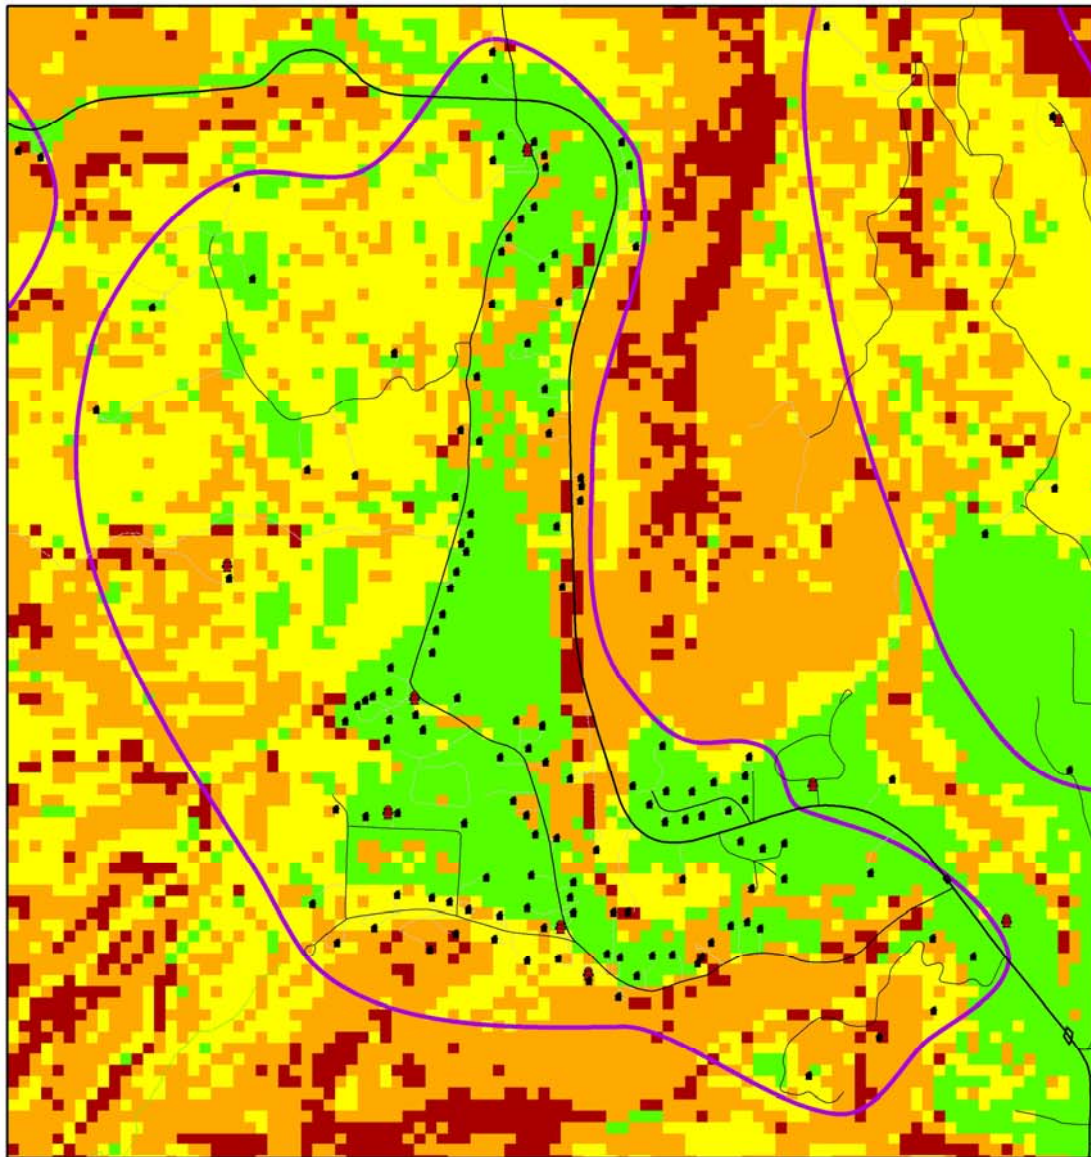
Combined Risk from Slope and Fuel Model

This map only shows the wildfire risk resulting from the combination of slope and fuel model. It does not reflect any other factors such as response times, home construction, defensible space or water supply.
